**STATE OF HAWAII**  
**HAWAII CORRECTIONAL SYSTEM OVERSIGHT COMMISSION**  
**E HUIKALA A MA'EMA'E NŌ**  
235 S. Beretania Street, 16<sup>th</sup> Floor  
HONOLULU, HAWAII 96813  
(808) 587-4160

**Hawaii Community Correctional Center (HCCC)**  
**August 2026 Site Visit Observations Report**  
**Date of Report: October 2, 2026**

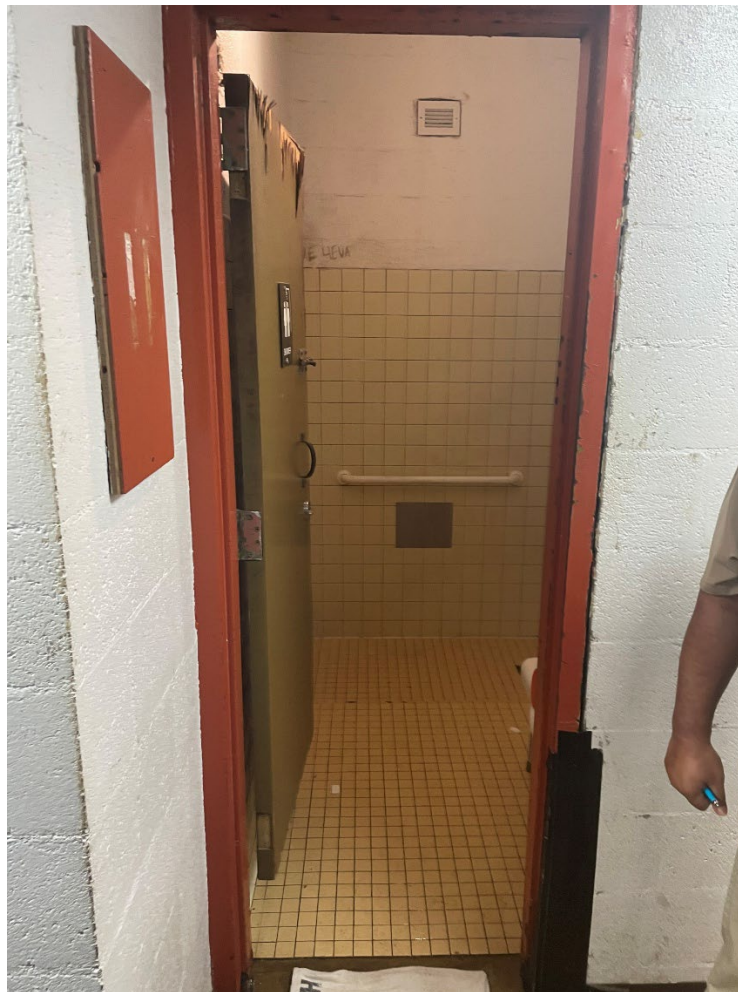
In the medical corridor, close to the cells where the women are held, is a small room with a shower. This is where the aforementioned women shower. The door, seen in the photo below, opens directly to the aforementioned hallway, or medical corridor, that is heavily trafficked by people being moved from intake to housing units. Additionally, parts of the shower room, such as the door seen in the photo, appeared to be in disrepair. The shower itself appeared to be leaking water.

*Bathroom used by women housed in Medical Corridor of Punahale*

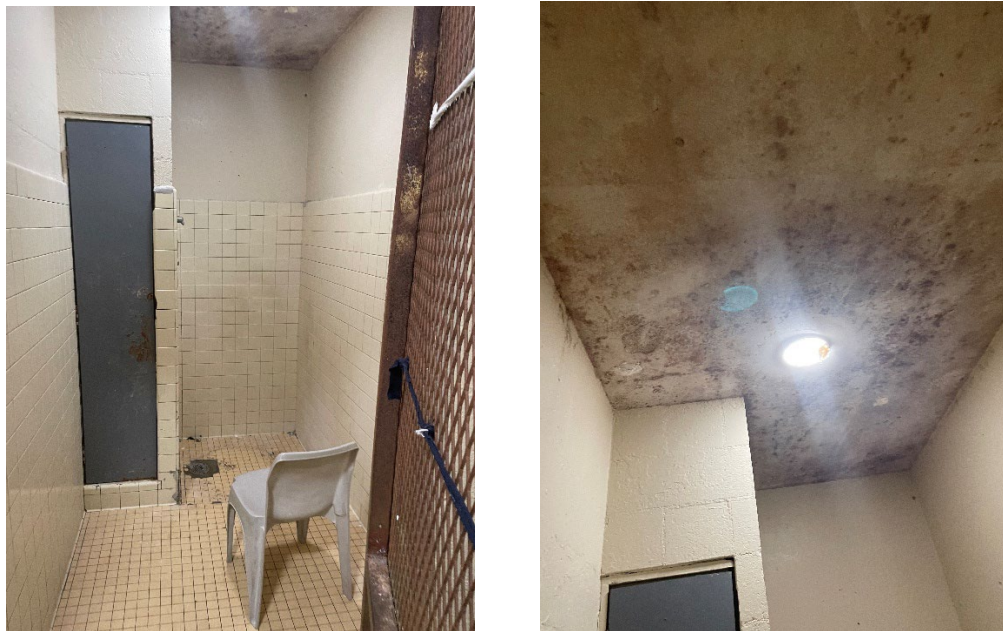
The K-Unit also included a shower that appeared to have mold on the ceiling, as seen below.

*Shower K-Units in back of Punahale*

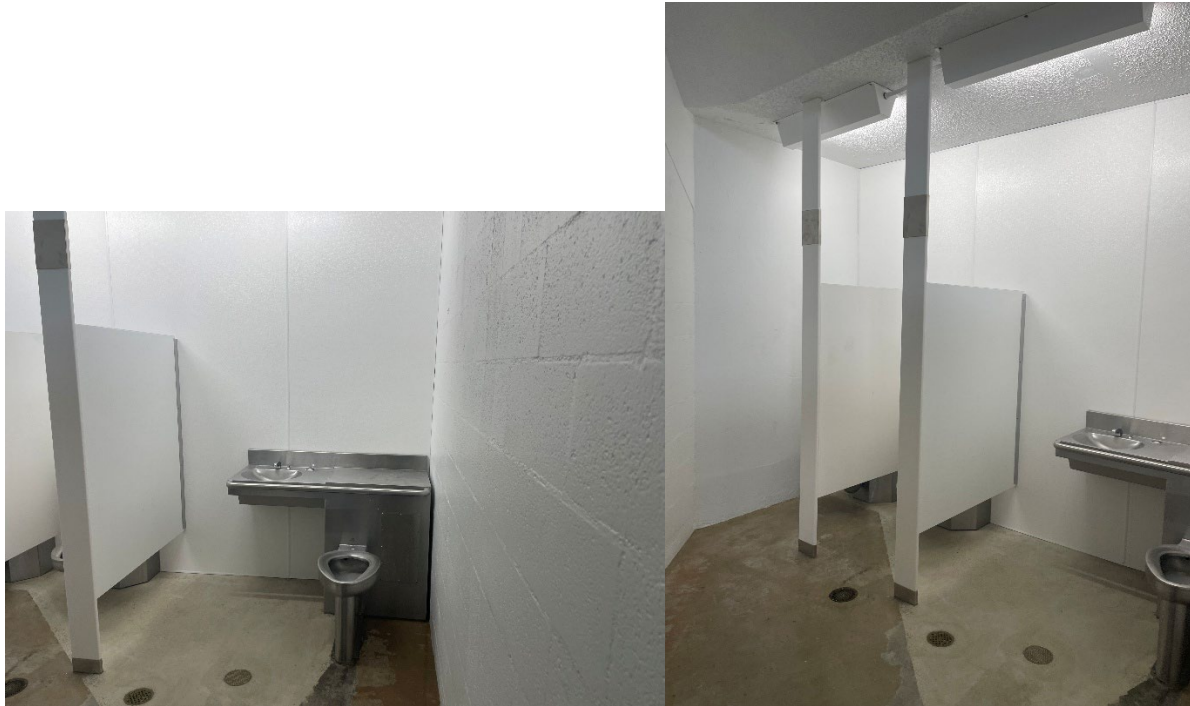
The Commission was pleased to find a renovated bathroom in Punahale that connects to the MP Floor (see below), featuring 3 toilets and sinks and ceilings with no mold. This renovation marks an important step toward eliminating all mold-infested bathrooms in the facility.

*Recently Renovated Punahele Bathroom*

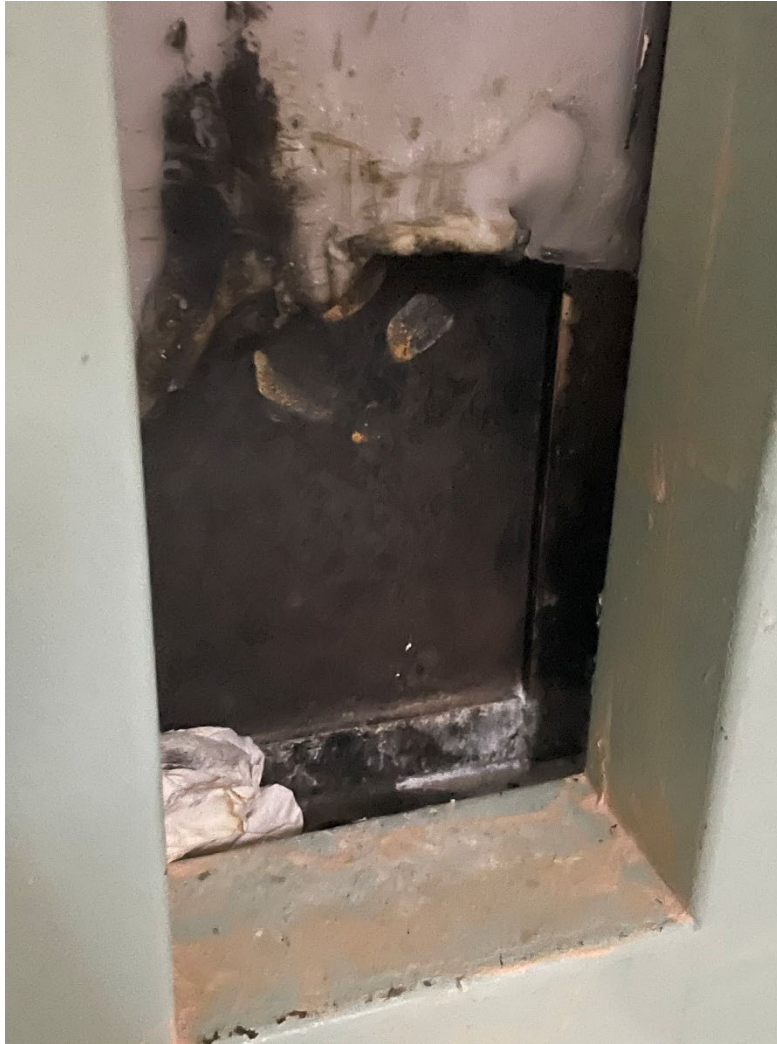
One of the cells downstairs, reportedly housing 4 people, requiring 2 to sleep on the floor, did not have any natural light. While most cells viewed by the Commission appeared to be appropriately fitted with opaque glass to allow natural light to enter, the window of the cell in question was fitted with a metal panel, secured from the outside. The panel appeared to be in place to cover a hole that appeared to be melted into the glass window.

*Cell Window in Komohana with metal plate covering and what appears to be melted plastic.*

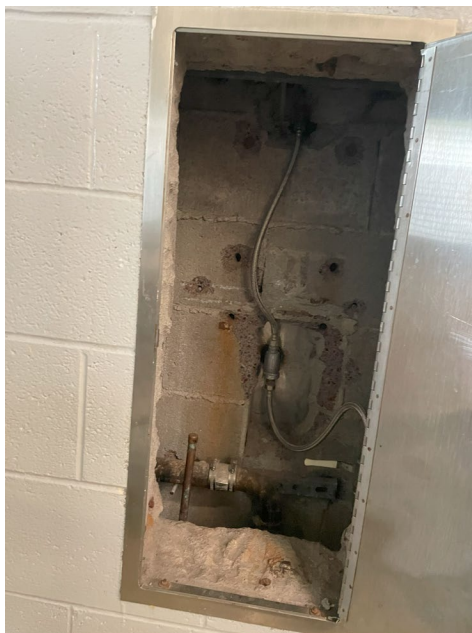
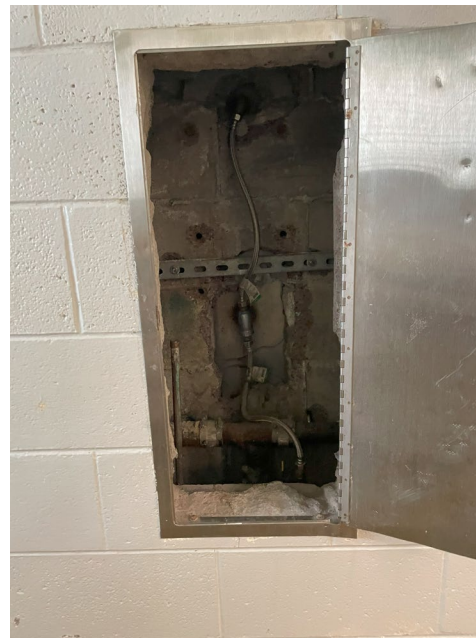
Additionally, showers used by the pretrial detainees did not have working shower handles to turn on the water. Showers are turned on by accessing water valves through 2 maintenance hatches located in a connecting area where beds are located, as seen below.

*Showers used by the those in Wainuenue did not have working shower handles to turn on the water.*

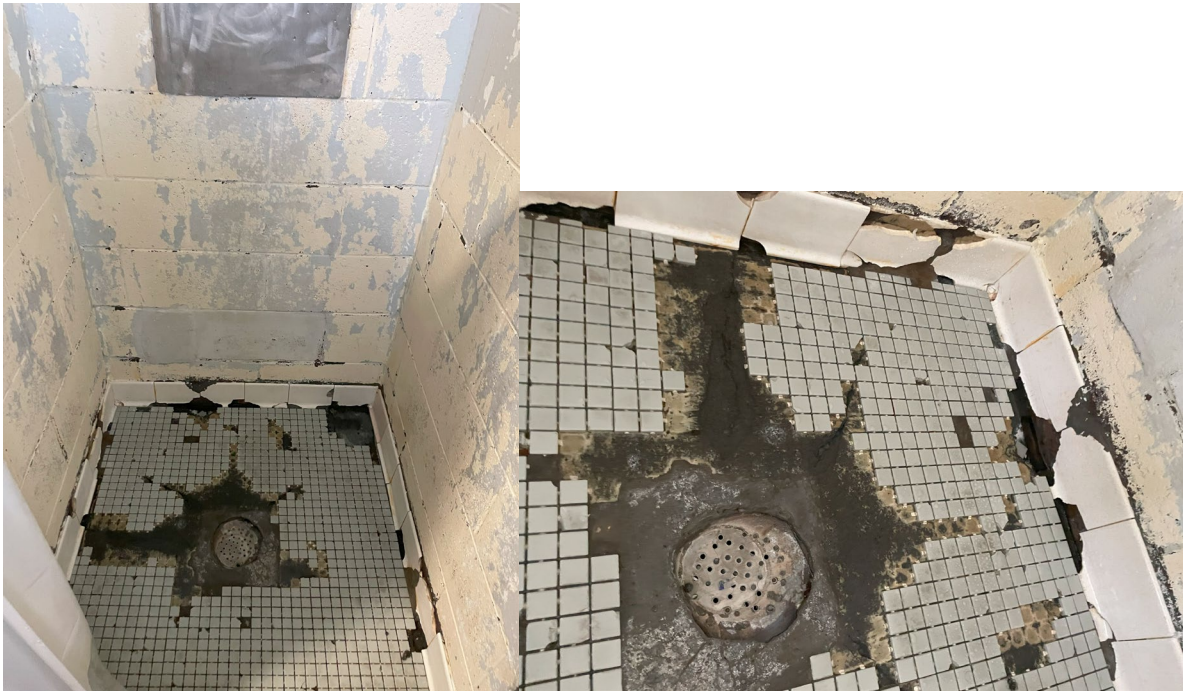
Showers in Wainuenue

Shower floors were also in disrepair, with several tiles missing from the shower floors, creating the potential for injuries to occur and sanitation issues to manifest.
